Abstract

In the wake of the devastating earthquake that struck Port-au-Prince, Haiti in 2010 is an on-going cholera epidemic. Informal settlements are hit particularly hard by the disease due to increased environmental exposures from crowded housing and lack of sanitation. The lack of infrastructure and dynamic nature of informal settlements necessitates a multi-layered approach to data gathering and problem solving. An in-depth approach to the spatial epidemiology of this outbreak is essential and can be partially achieved by implementing a technique known as Spatial Video. Using GPS-enabled, high-definition cameras, local health workers can film the environment, documenting cholera risks overtime, at a level of detail otherwise unattainable by conventional mapping methods. The resulting information will be digitized in Google Earth and then coded and analyzed in GIS.

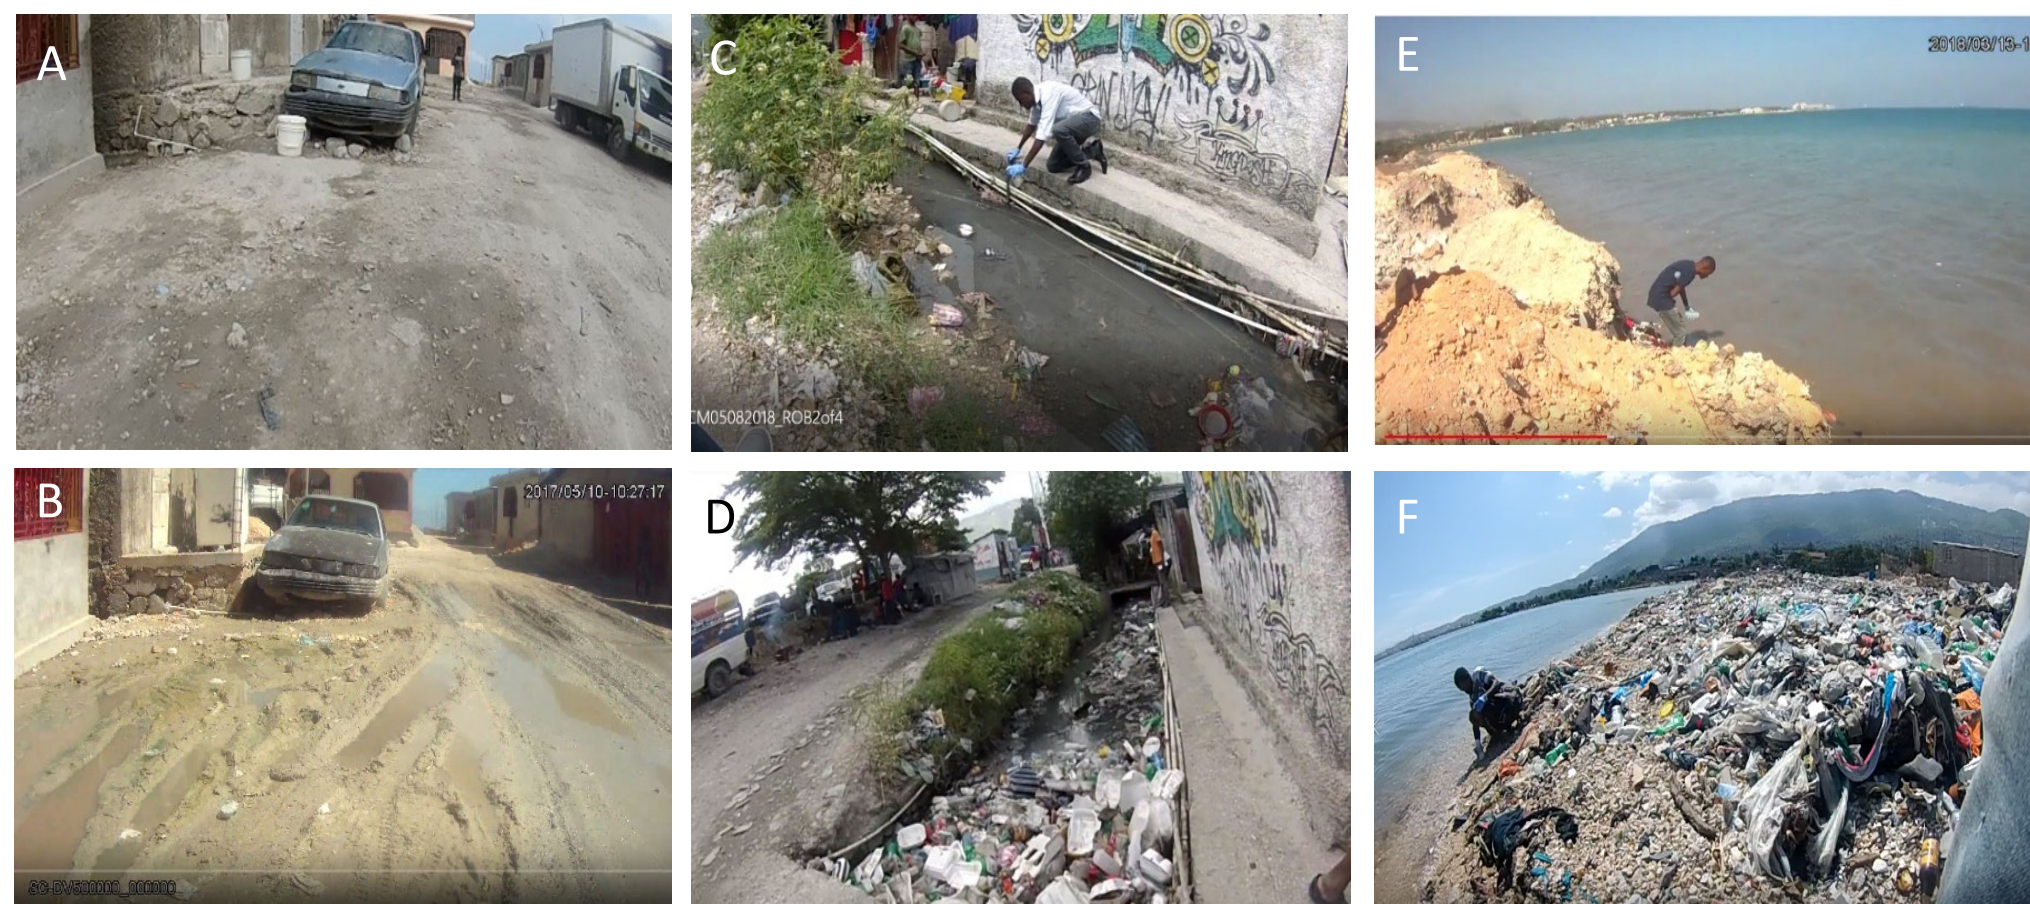
Figure 1. Images of environmental risks changing over time.

Figure 1. Images of three different water points over time. Images A and B show an increase in water and mud at a water pipe; B and C show an increase in trash in a drainage channel; E and F, an increase in trash at the ocean

Video from four different time points, spanning May - August, was analyzed (**Figure 1**). Severity scores of four and five are grouped into a “severe” category and the grouped proportions calculated for each risk category, at each time point. Severe risks are found in variable proportions in each risk category over time; the proportions ranging from 0 – 100 % with the May and July months having the highest proportions of severe risk scores. At each time point, except for August, the risk categories that most frequently exhibited severe scores were water and trash; during the August time point, activity had the greatest proportion of severe scores (**Table 1**).

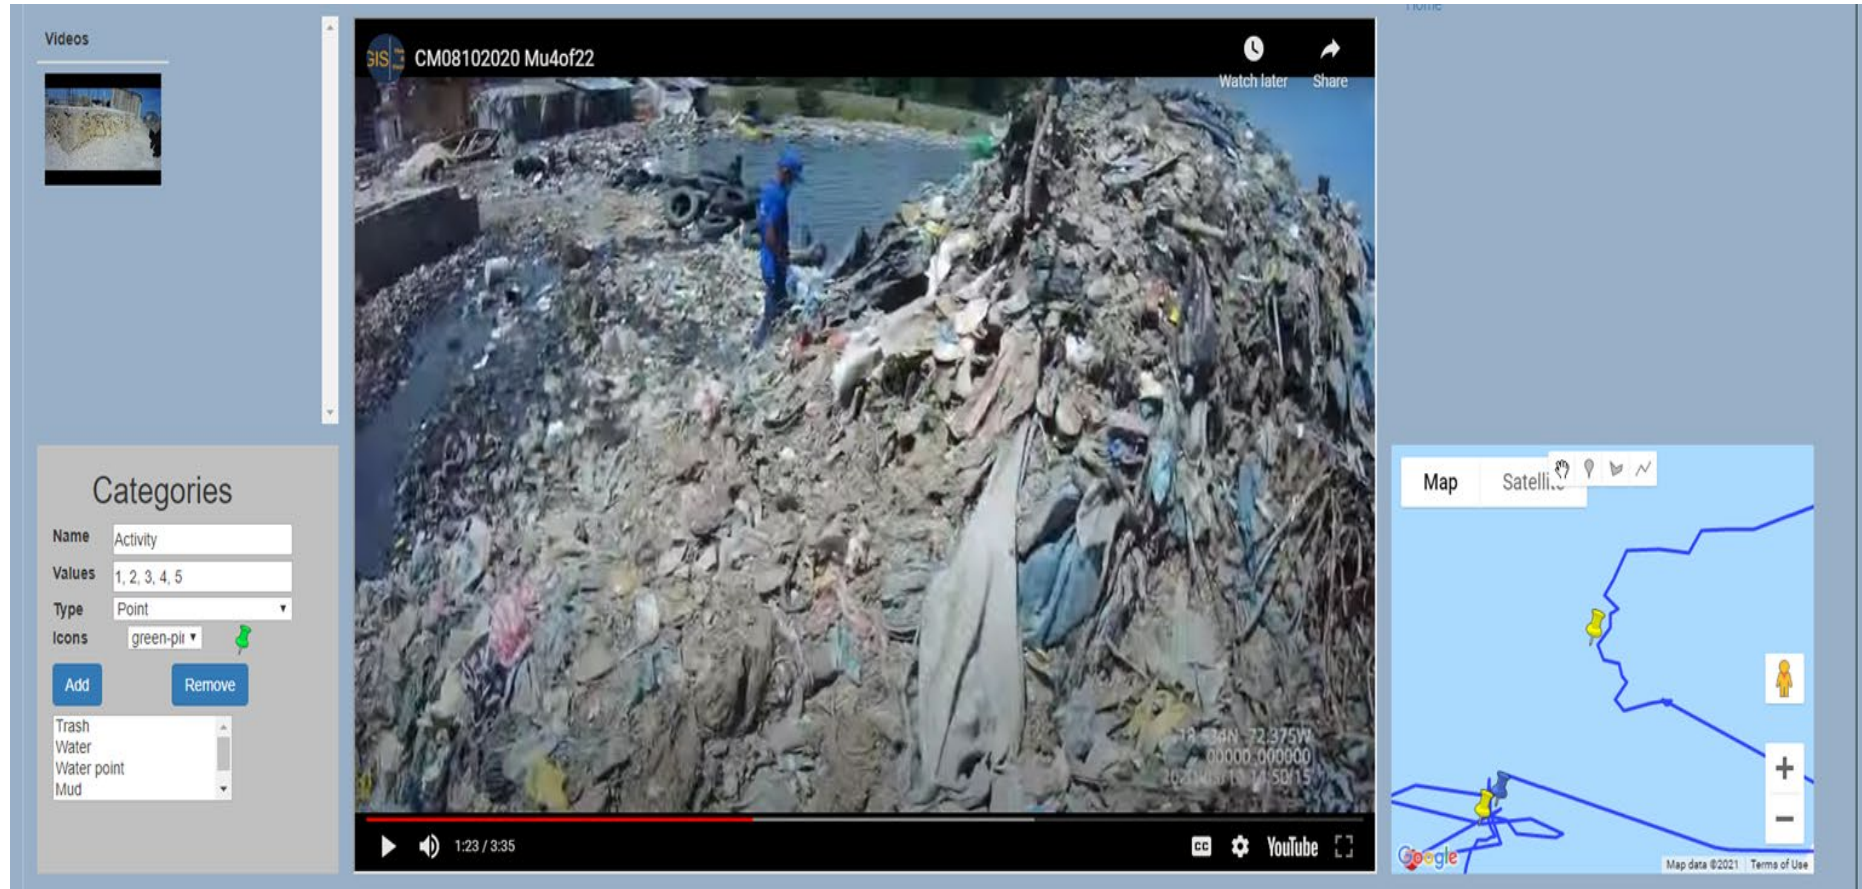
Figure 2. Digitizing video into risk maps

Figure 2. Video and GPS are synchronized and uploaded into Spatial Video software (developed in house) and environmental risks are identified and pinned on map.

Study site. Cite Michel is an informal settlement in coastal Port-au-Prince, Haiti and a stronghold for the cholera epidemic. There are 14 water access points that served as the focal point for video collection; nine are clean water and five are dirty drainage water. **Study design:** Serial cross-sectional audit of the built and social environment. **Data collection:** SV was used to collect street-level information, including standing water, mud, trash, and presence of animals and people (**Figure 1**). The videos were collected monthly from May – August in 2020. Each water point and the path walked is rated on a scale of one through five for each of the risk factors listed above. A score of one is considered mild or nonexistent and five is severe. **Analysis:** Data were digitized into Google Earth and then coded and analyzed in ArcGIS (**Figure 2**).

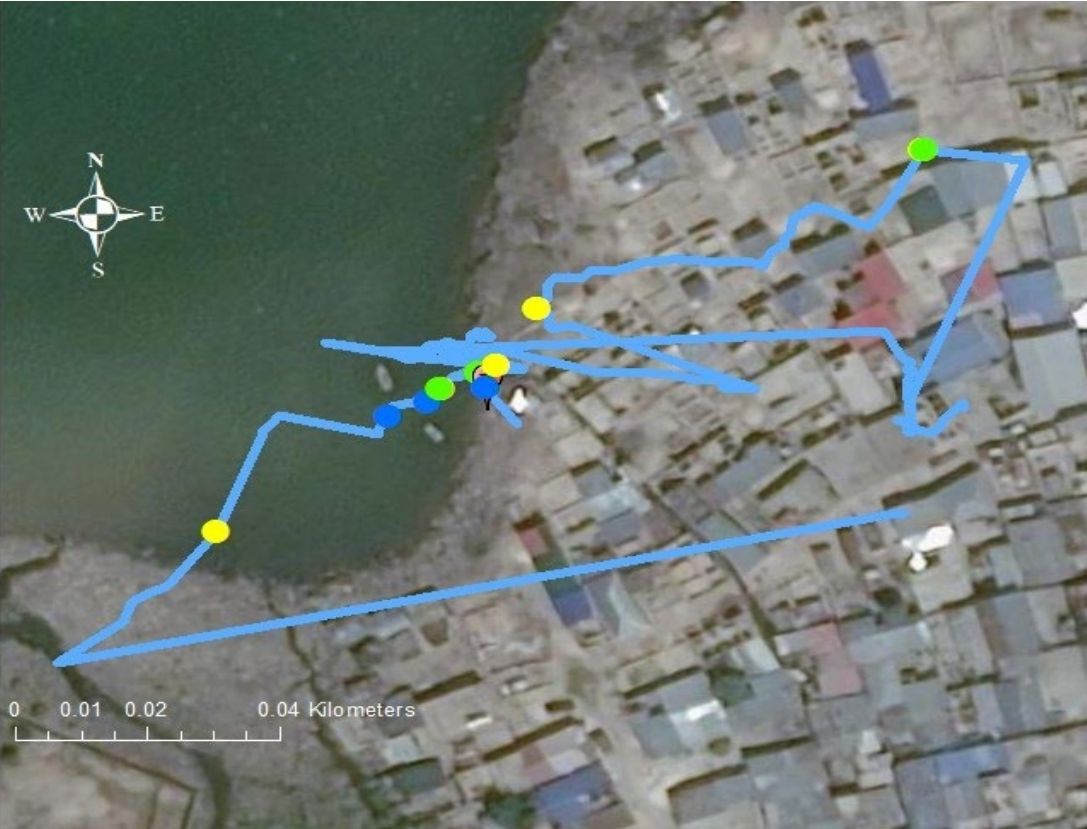
Figure 3. GPS path and identified risks

Figure 3. Synchronized video and GPS are digitized into Google Earth Pro, then imported into ArcGIS to generate a map of risk locations. All three time points combined to show relative proximity of risks.

The cumulative body of evidence uncovered in this study supports the findings reported in the literature that informal settlements are dynamic and challenging environments that require nuanced mapping techniques. Video captured from the same sites over time shows varying degrees of risk severity. Using SV, risks can be identified, synchronized with GPS, and mapped so as to provide in-depth information about street-level cholera risks (**Figure 3**).
